# Manhole Inspection Summary

Manhole # S23II1018MH

**Location** Address: **1414 MEDFIELD AVE**

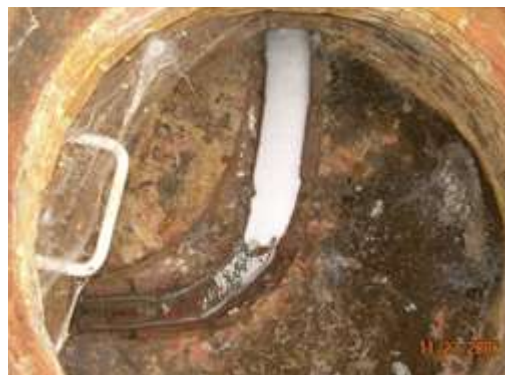
Top View

Adjustment and Barrel infiltration. Bench debris.

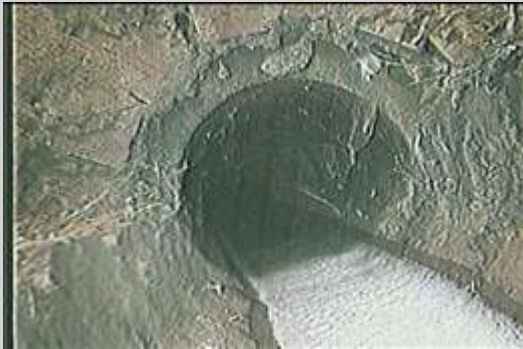
### 8 in. Circular Gravity Sewer Pipe Out @ 12 O'Clock

Infiltration: **Evidence** Pipe Seal Cond: **Unknown**
